Architectural Approaches for Biological Filtration of Nutrients In Golf Course Runoff Water

Eric Miltner, Gwen Stahnke, William Johnston, and Geoffrey Rinehart
Washington State University

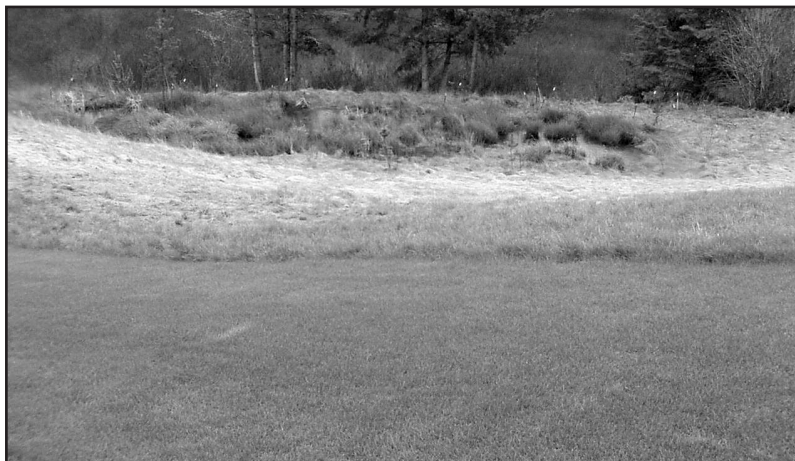
Grass buffer and artificial wetland designed to filter contaminants from water before flowing into natural wetland and lake.

This project is being conducted at a golf course on the Olympic Peninsula. A natural 18-acre lake surrounded by wetland is the drainage basin for 16 of the golf course's 18 holes. The entire golf course was constructed with a 6 to 10 inch deep sand cap. In addition, "bioswales" (mounded berms), "wet cells" (low-lying graded areas that seasonally contain water) and artificial wetlands were included at edges of fairways and in roughs. These features were designed to intercept runoff water and allow for uptake of nutrients from the

water by plants and soil microorganisms. Soil solution samplers were installed up gradient, within, and down gradient from selected bioswales, wet cells, and wetlands. Samples are collected periodically and analyzed for inorganic nitrogen and orthophosphate (soluble phosphorus), two potentially important pollutants of surface and ground water.
